Hygiene Report

Client Novartis Healthcare A/S

Poultry house number 1 (7200 m² surface) **Subject**

Test date 15 and 16-02-2012 **Performer** Ove Christoffersen

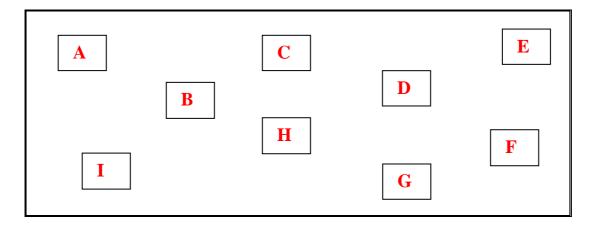
POULTRYHOUSE: test spots

Red letters are test spots on floor

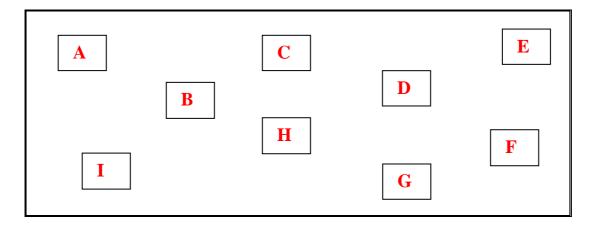
POULTRYHOUSE: test spots

Red letters are test spots on floor
